SUBMARINE FORCE MUSEUM

Allied Restoration, Inc. was contracted by the U.S. Navy to upgrade and repair the building envelope. Allied requested Daniel's Caulking to evaluate the need for sealant replacement in the metal cladding as one component of the upgrade. Daniel's Caulking chose Pecora Corporation to assist in inspecting the existing sealant installation and to make recommendations for its successful replacement.

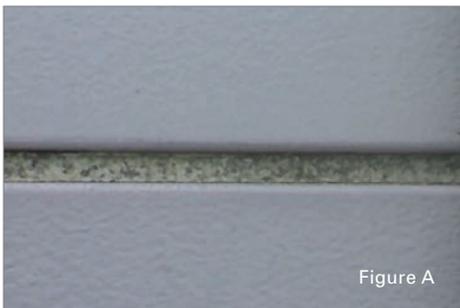
Upon inspection of the building, it was evident the previous sealant failed allowing moisture to penetrate the building envelope and cause damage to the joints within the metal cladding. See Figure A.

The owner chose to leave the existing sealant in place and apply Pecora SilSpan over the joint. SilSpan is an ultra-low modulus silicone extrusion designed to span the existing failed joint and provide a weather tight primary seal. It seals joints from moisture in EIFS and accommodates expected movement within the joints, while eliminating costly substrate repairs required in the event a failed sealant is removed.
