YAKIMA HUMANE SOCIETY YAKIMA COUNTY, WASHINGTON

PECORA-DECK HB1000

High build, fast curing, industrial grade urethane traffic bearing membrane

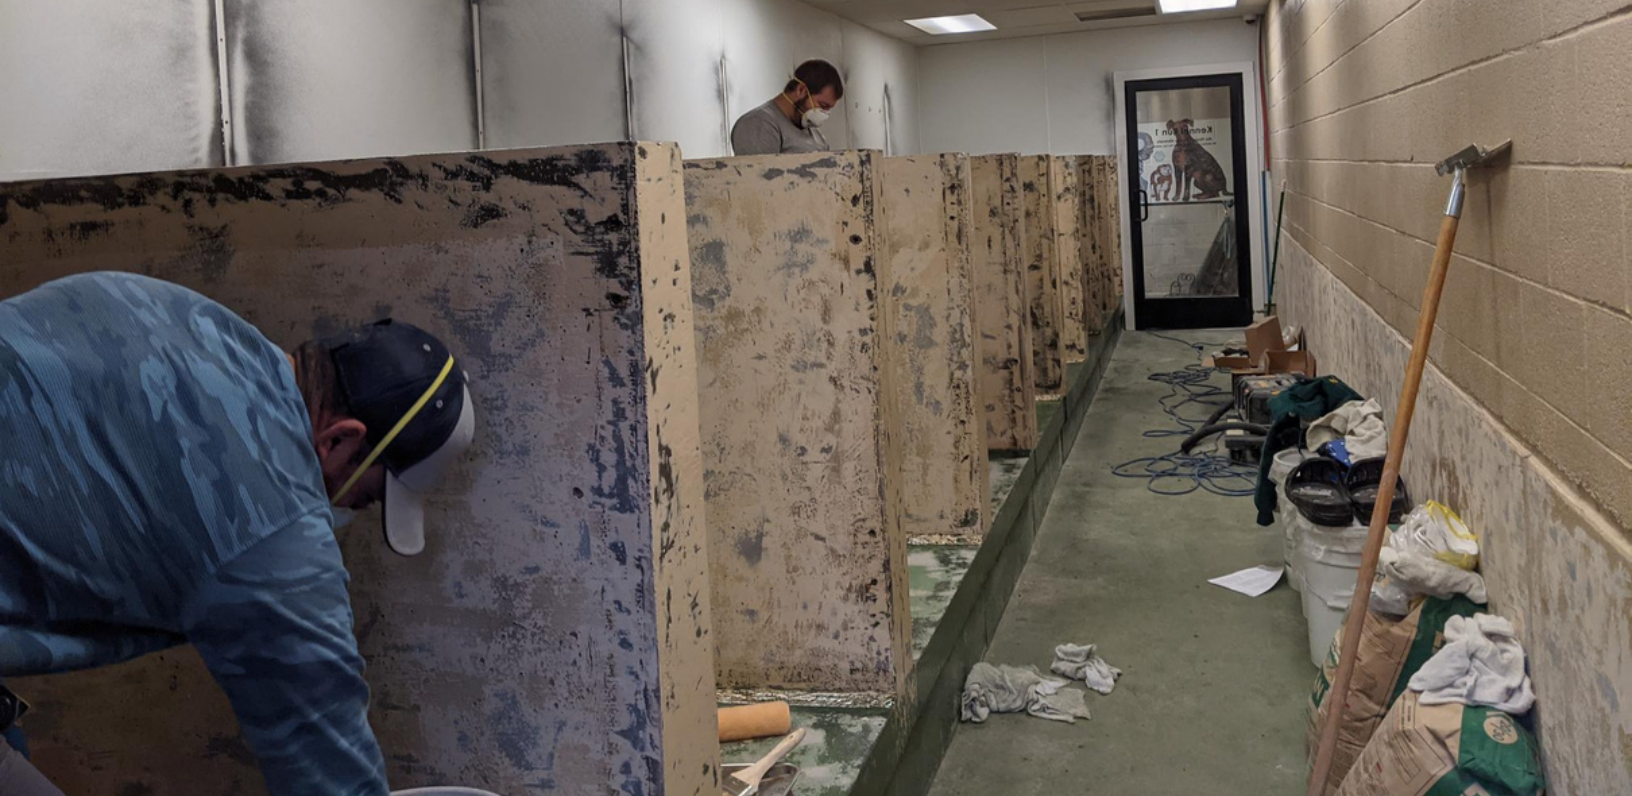
The previous epoxy coating that covered 76 kennels around the facility was beginning to fail and exhibit signs of de-lamination. Owners decided a re-coat was necessary to protect and extend the life of the structure. With plenty of lives to take care of, the last thing facilitators want to worry about is a failed coating. To remedy this issue, owners sought an easy to clean coating that would wear better than the previous epoxy. Because these kennels are enclosed, the coating needed to offer low odor for installers, animals, and the Humane Society staff. Although there would be no dogs in the bays during installation, there was still a chance of lingering odors spreading to both staff and animals. There was also a need for minimal downtime so the animals could be quickly returned to their kennels. Pecora Corporation was not originally spec'd for the project. Our Northwestern Sales Representative, Steve Swim, met with the contractor on the job, Pride Construction, to discuss options for the kennels. Pride Construction has worked with our products in the past and has always felt we provide reliable products. With so many animals to manage, the team needed a plan that caused the least amount of stress on the animals.

Pecora-Deck HB1000 High Build Traffic Membrane was selected for the project. Pecora-Deck HB1000 is a high build, fast curing, low odor, industrial grade urethane traffic bearing membrane. HB1000 protects traffic and non-traffic bearing substrates from physical abuse, water infiltration, and chemical resistance. The system was applied in two coats: P-808 Epoxy Primer and then HB1000 membrane at 25 mils. Pecora suggests applying the wet film thickness of approximately 15 to 20 mils to achieve satisfactory coverage. The 25 mils thickness was chosen because the coating is intended to handle daily cleanings as well as anything dogs, cats, etc. can throw at the system. This thickness was chosen to withstand the conditions in the kennel, ensuring protection against long-term wear.

Crew size is critical when applying HB1000 due to the product's short pot life. The tradeoff of course is a quick return to service. For this project, there were four to six crew members. To prepare for application, grinding wheels were used in confined kennels to remove debonded material from the CMU block substrate. Next, contractors combined pails of HB1000 with Part A and Part B activator for four minutes to ensure proper mixing. Each individual was given a gallon worth of material to detail all corners of the kennels with brushes and began working on the vertical lifts (up the walls). In this case, that meant roughly four feet up the wall. Once completed, a second pail was mixed and troweled and/or squeegeed onto the floors of the kennels. One individual was responsible for mixing and placing material, while four others knocked out the floor application with $\frac{1}{4}$ notch squeegees and tied into the wall sections that were completed earlier. Having chip brushes, roller frames, and squeegees in place, and a specific job for each worker made the coating process move extremely quick and with a minimal amount of wasted material. Getting coatings to hang on a vertical substrate is not easy, especially CMU block. The coating was applied by cross rolling all areas. By applying the coating in this manner, contractors were able to minimize any sag. Kennel walls and floors were completed in 1.5 to 2 hours.
