## FRUIT PRODUCTION PLANT EASTERN WASHINGTON, USA

### PECORA DYNATHANE 800MM CONTROL JOINT RESIN

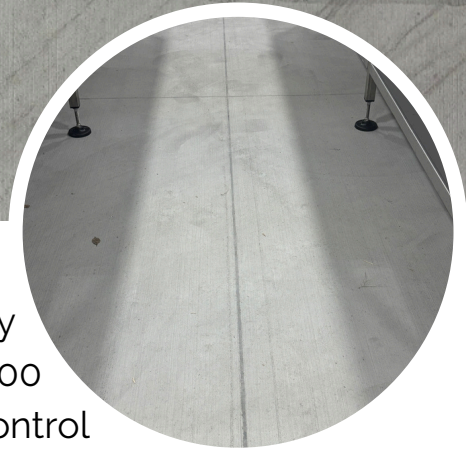
In Eastern Washington, a large fruit production plant completed a significant flooring upgrade to improve durability and performance in its high-traffic facility. To protect over 3,500 lineal feet of concrete joints, Pecora's DynaThane 800MM, control joints resin, was selected and installed using 10-gallon kits. This joint protection system was chosen for its strength, reliability, and ability to withstand the rigorous demands of a busy food production environment.

DynaThane 800MM is a two-component, rapid-curing, semi-rigid polyurethane/polyurea hybrid control joint resin designed to protect concrete floor joint edges from spalling caused by heavy industrial traffic. Its rapid cure time allows it to be ready for light traffic in as little as fifteen minutes at 75°F, ensuring minimal disruption to plant operations. The product's Shore A hardness of 85 provides long-term wear resistance, making it a reliable solution for facilities that require durability under constant stress.

The installation began with careful surface preparation to ensure all joints were clean, dry, and free of debris, which is essential for achieving proper adhesion. Using 10-gallon bulk kits, the team employed dual-component pumping equipment to achieve the precise 1:1 mix ratio required for the product. Once mixed, the DynaThane 800MM was dispensed directly into the joints, slightly overfilled to create a protective crown. After curing to a solid state, typically within fifteen minutes at standard temperature, the material was shaved flush with the surrounding floor surface. The rapid curing time significantly reduced downtime, a critical advantage for this high-output facility.
